# Crack propagation analysis of compressor blade subjected to resonant vibrations

In this work the crack propagation analysis of the compressor blade of aero engine was performed. During investigations the blade with mechanical defect (notch) was considered. In experimental analysis the blade was subjected to resonant vibration. During transverse vibrations, a high stress occurs in the blade. Pulsation of stress causes the fatigue of material. In results of proposed investigations both the number of load cycles to initiation and also the crack growth dynamics was obtained for the blade working in resonance condition. In second part of work the maximum principal stress distributions in the vibrated blade were determined using finite element method.

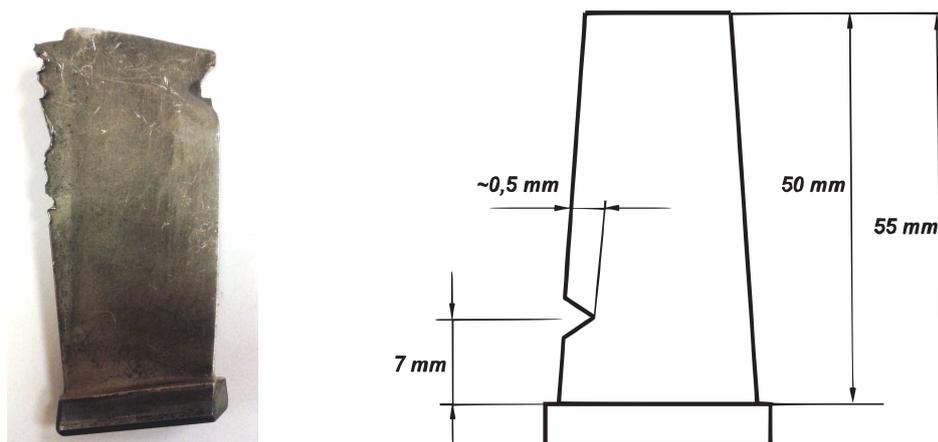
Figure 1: View of blade damaged by foreign object (a), dimension of the investigated blade with v-notch (b).

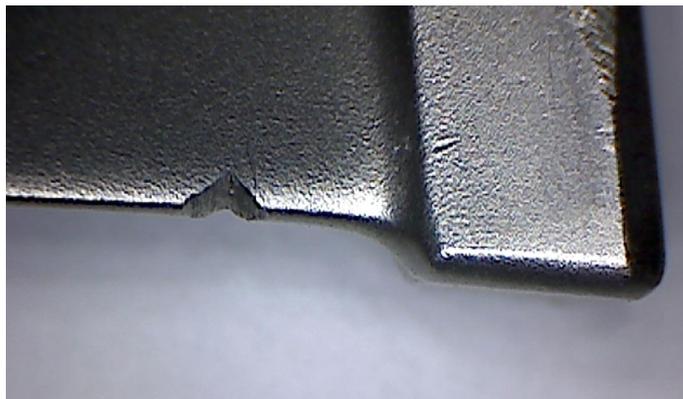
Figure 2: V-notch created on the attack edge of investigated blade.

In investigated blade a V-notch presented in Fig. 2 was created. The depth of notch was about 0.5mm whereas the apex angle 90 degrees. The notch in the blade was created by machining. The compressor blade was made out of EI – 961 steel (0.11C; 11Cr; 1.5Ni, 1.6W; 0.18V; 0.35Mo; 0.025S; 0.03P) with the following properties (measured in temperature 20°C): Ultimate tensile strength 900–1000MPa, Yield stress 800–900MPa, Young modulus 200GPa, Poisson ratio 0.3. The high cycle fatigue tests of the blade were made using the Unholtz-Dickie UDCO TA-250 electrodynamic vibration system, presented in Fig. 3 at Laboratory of Turbomachinery of Rzeszow University of Technology. The blade with a notch was horizontally mounted on the movable head of vibrator (Fig. 4). Next the head of shaker was entered into harmonic vibration. In first step of analysis the resonance frequency was determined (for first mode of transverse vibration). The fatigue test was started from frequency close to resonant. During investigations two main parameters were periodically monitored: vibration amplitude of the blade tip and the size (or existence) of the crack. For control of amplitude the laser scanning vibrometer POLYTEC PSV H-400S were used. To measure the length of the crack a nondestructive fluorescent penetrant method was utilized.

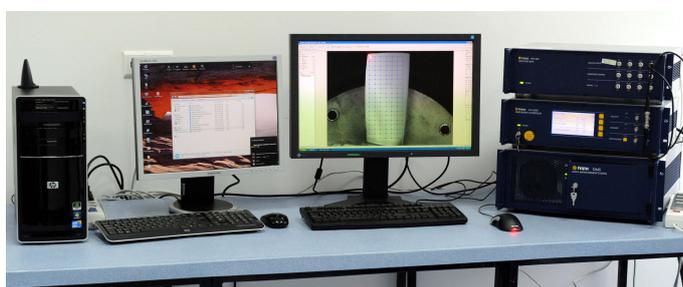
Figure 3: View of control systems of both laser scanning vibrometer and the shaker used in experimental investigations.

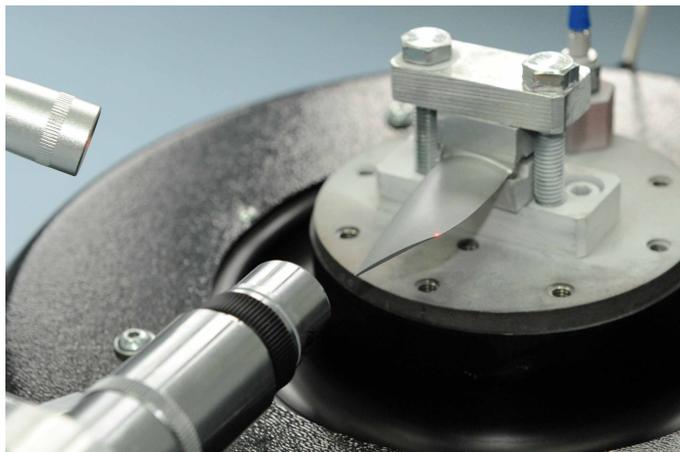
Figure 4: Compressor blade fixed to movable head of vibrator.

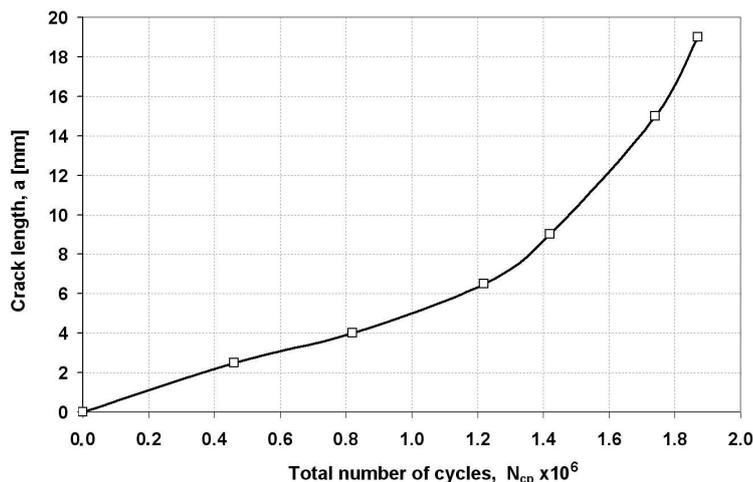
Figure 5: The crack length in function of number of load cycles  $N_{cp}$  (counted from crack initiation) for blade subjected to resonant vibration (first mode,  $A = 1.2\text{mm}$ ).

Obtained results (Tab. 1) showed that the blade with v-notch created by machining, needs  $N = 12 \times 10^6$  total number of load cycles to crack initiation. The crack propagation process was much shorter. The crack needs  $N = 1.87 \times 10^6$  number of load cycles for propagation from length  $a = 0$  to final crack size  $a = 19\text{mm}$  (at which the blade was broken). Thus, in presented case the crack initiation process ( $N = 12 \times 10^6$ ) is a main part of fatigue life of the blade ( $N = 13.87 \times 10^6$ ).

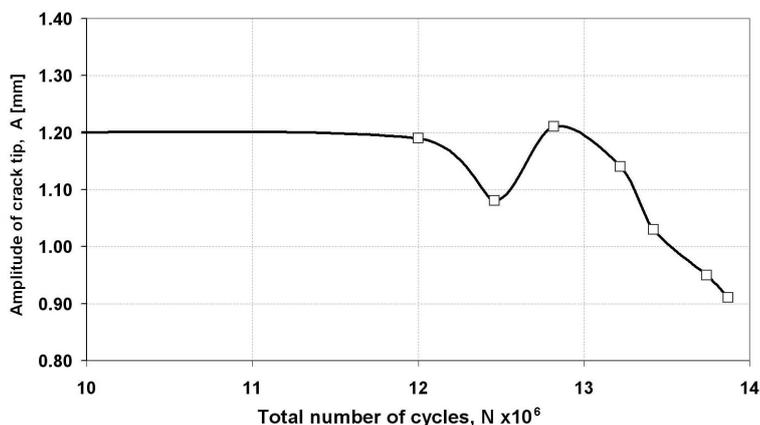
Figure 6: Amplitude of crack tip displacement (vibration amplitude) as a function of number of load cycles  $N$ .

The assumption of work was to maintain the blade tip displacement amplitude (vibration amplitude) on constant level. However this condition is difficult for satisfy during all fatigue test. The vibration amplitude in the blade was constant until about  $N = 12 \times 10^6$  number of cycles (Fig. 6). Just after crack initiation, the blade stiffness decreases and in consequence of them the lower value of blade amplitude ( $A = 1.08\text{mm}$ ) was observed (at  $N = 12.46 \times 10^6$ ). To maintain the blade amplitude on level  $A = 1.2\text{mm}$  the frequency of excitation was next decreased. In the range of  $N = 12.82 - 13.10 \times 10^6$  number of load cycles, the blade amplitude was close to initial value, but after  $N = 13.42 \times 10^6$  the vibration amplitude decreased more quickly. The last part of fracture is highly unstable process. The increase of intensity of vibration (to value of 12g and 14g) in finish part of fatigue (Fig. 7) caused that

the vibration amplitude was still not constant (Fig. 6).

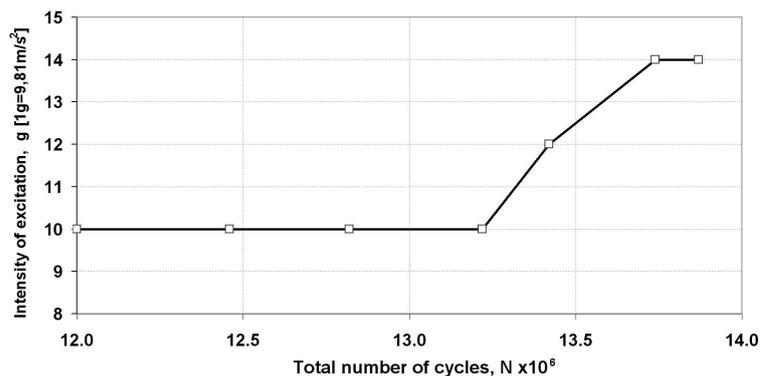
Figure 7: Intensity of excitation (vibration) in function of number of load cycles  $N$ .

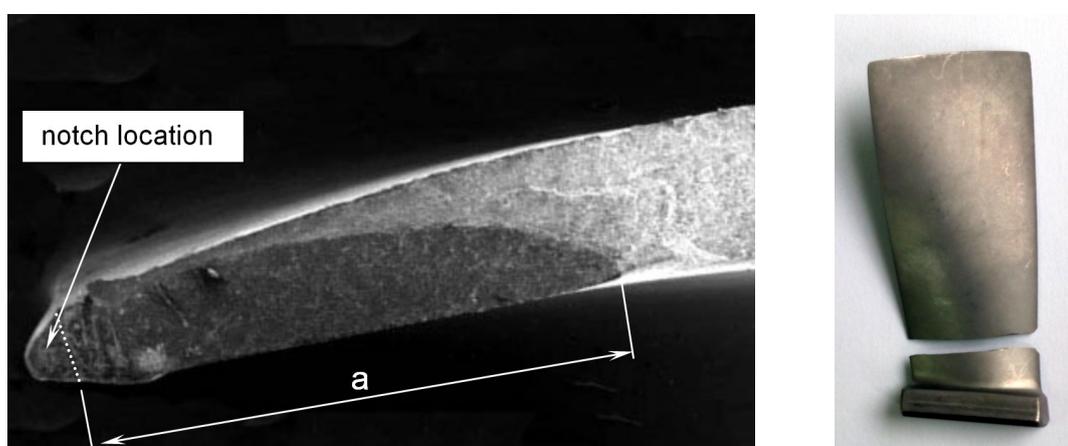
Figure 8: Fracture of blade with 6.5mm long crack ( $a = 6.5mm$ ) (a) and the blade after finish of fatigue test (b).

Shape of crack in preliminary phase of growth is presented in Fig. 8a. As seen from this figure, the crack in first phase of growth propagates more quickly along the concave surface of the blade profile. In Fig. 8a is also distinguished the crack length ( $a$  dimension) used to description of vertical axis of plot presented in Fig. 5. The blade after finish of the fatigue test is visible in Fig. 8b. The crack direction is not parallel to blade lock. The crack starts from the notch located 7mm above the lock. The crack in finish part of fracture achieved the trailing edge of the blade, about 5mm above the lock.

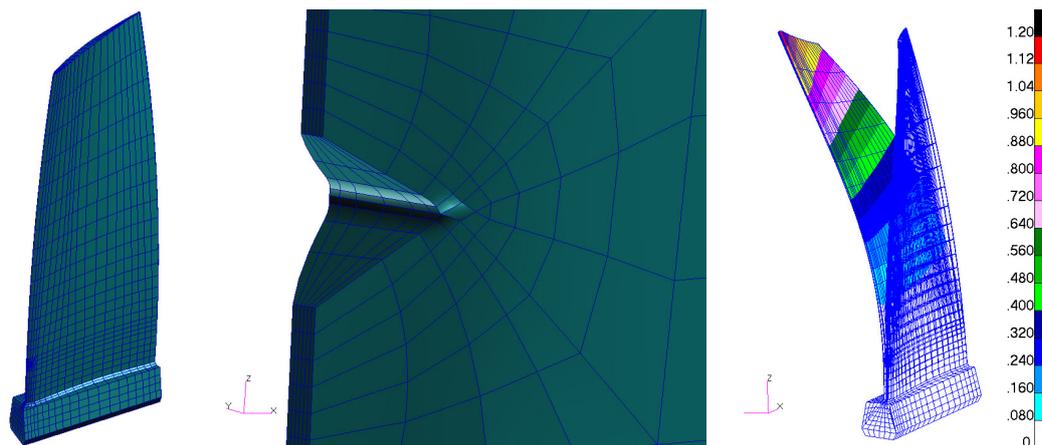
Figure 9: View of numerical model of compressor blade (a), magnified notch area (b) and values of displacement of blade during first mode of free vibrations, [mm] (c).

For definition of stress state in the blade subjected to HCF, the finite element analysis (FEA) was performed. In this analysis the first mode of transverse vibration was considered. To solve this problem, the Patran program was used to both geometrical and the finite element model preparation. In Fig. 9a the discrete model of blade with the notch located 7mm above the lock was shown. In the notch vicinity the finite element mesh was concentrated (Fig. 9b). In the next part of work Abaqus software were used for stress and modal analysis of the compressor blade. Results of FEM analysis (Fig. 9c) showed that during first mode of resonant vibration the blade are subjected to cyclic bending. During transverse vibration the maximum value of amplitude of displacement (on blade tip) is equal to 1.2mm. All numerical results are obtained for the same vibration amplitude ( $A = 1.2\text{mm}$ ) and for left

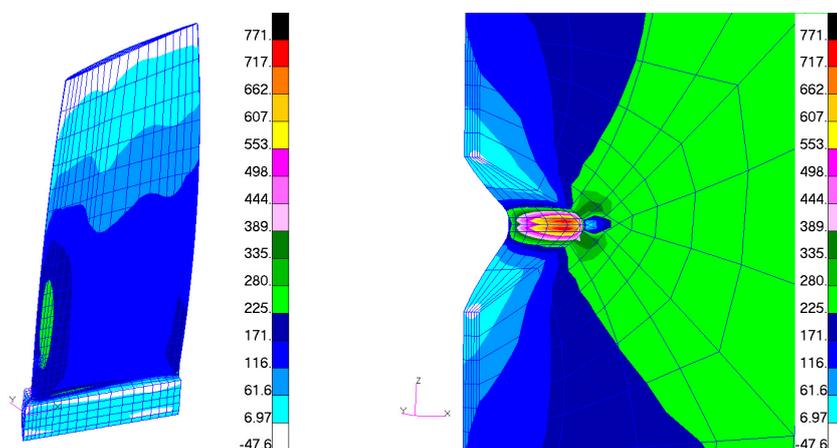
Figure 10: Values of maximum principal stress for the blade (a) and in the vicinity of notch (b), [MPa].

blade deflection at which the maximum principal stress in the blade was observed. Figure 10a showed that value of maximum principal stress value in the zone located near the attack edge of blade is about 225 – 280MPa. The area of maximum stress (771MPa) is located in the notch vicinity (Fig. 10b). Maximum principal stress values in cross-section of blade (in fracture plane) showed that during left blade deflection the tension stress occurred in the zone near concave surface of blade (Fig. 11). Just in this region the crack propagate more quickly than in convex profile area. Obtained results showed that cyclic tension stress in blade cross section is a main reason for crack initiation and crack propagation of the blade subjected to resonant vibration.

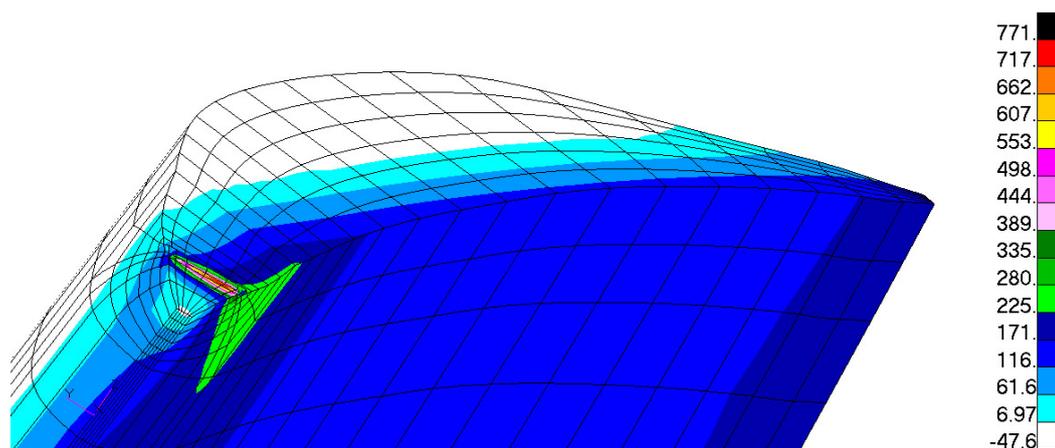
Figure 11: Values of maximum principal stress in cross-section of blade (at level of notch), [MPa].
