CHARACTERIZATION OF DARK GREEN PASSIVATION FILM ON GALVANIZED STEEL SHEET

Abstract. Galvanized Steel Sheet was dark green colored passivated in tetracid solution system with acetic acid solution as stabilizer and silver salt solution as toner. The micro-morphology of the film before and after passivation was observed by SEM. The composition of the film was tested by EDS and its phase composition was analyzed by XRD. The corrosion resistance of the passivated film was studied by neutral salt spray test. The results showed that the surface of the specimen without passivation film was complete consecutive and coarse electrodeposited zinc coating. The surface became homogeneous and smooth, and turned dark green with the uniform colour and soft brightness but had chap structure. The film was composed of Cr, O, P, Zn, and a small amount of Fe element. There were phases in the film, including CrPO_4 , $\text{Cr}(\text{OH})_3$, CrOOH , Cr_2O_3 , $\text{Zn}(\text{OH})_2$, $2\text{ZnORCrO}_3\text{RH}_2\text{O}$, $\text{Zn}_3(\text{PO}_4)_2\text{R}_4\text{H}_2\text{O}$, and Ag. Zinc coating, passivation film, and Fe matrix combined closely, and no defects appeared such as crack. The total th

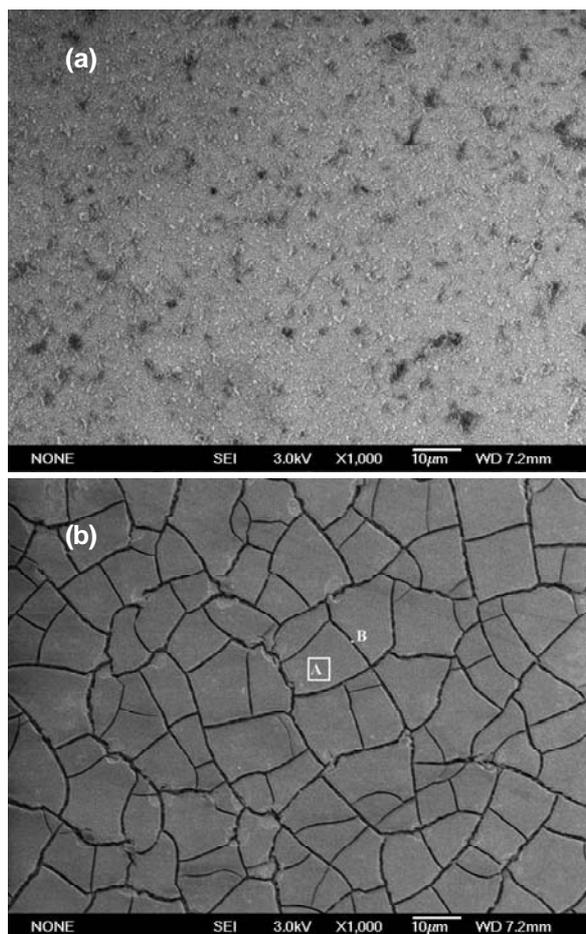
Fig. 1. Surface morphology of the specimens with and without blackishgreen colored passivation film: (a) Specimen without passivation film; (b) Specimen with blackishgreen colored passivation film.

Fig. 1 showed that the specimen without passivation film had high surface roughness and many holes in dendritic gap. Surface of the sample showed a complete continuous layer of zinc electrodeposition. The figure also showed that after passivation the surface became clear smooth, roughness decreased, but there were structural chap.

(2) Sample surface before passivation presents a complete electro-galvanized layer. After passivation the sample surface becomes clear smooth, but there were chaps, the chap place of passivation film was thin and rich in zinc and iron, surface chaps did not affect the corrosion resistance of passive film.

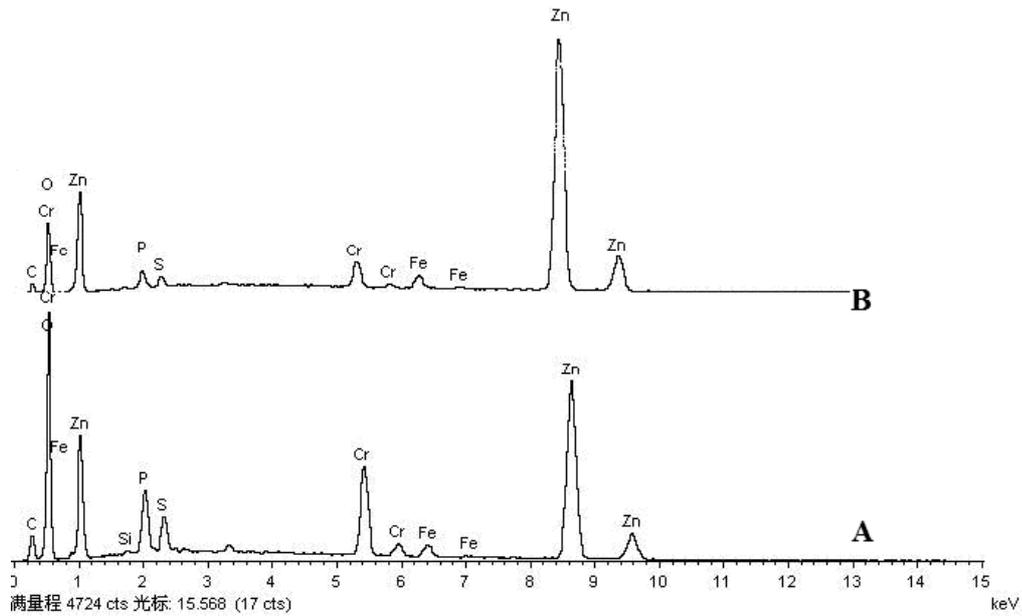
Fig. 2. EDS patterns of different positions on blackishgreen colored passivation film in Fig. 1.

Fig. 2 and Table 1 showed that the Chemical Constituents were different between the smooth region A and the chap place B of passivation film. The element contents of Zn and Fe were lower significantly in the place of A than B, however the contents of O, P, S, Cr were higher. The passivation film was uniform dense in the smooth region, it was thinner in the chap place and contained more Zn and Fe.

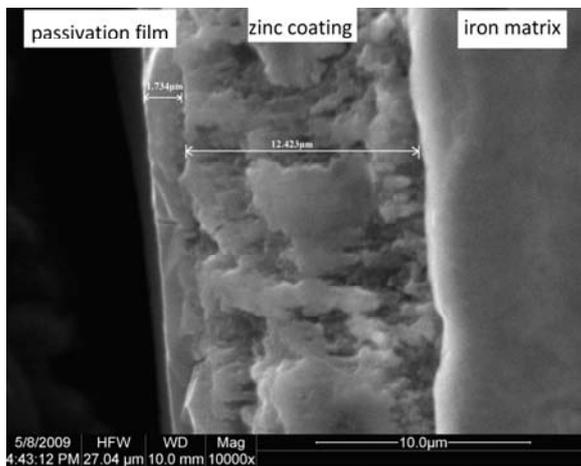
Fig. 3. Fracture surface SEM morphology of specimen with blackishgreen colored passivation film.

Fig. 3 showed that Zinc coating, passivation film and Fe matrix combined closely, and no defects appeared such as crack. The total thickness of zinc coating and passivation film reaches $12.423 \mu\text{m}$, and dark green passivation film is $1.734 \mu\text{m}$. Passivation film was uniform and dense, galvanized coating presented beautiful equiaxed zinc spangle.

(3) Zinc coating, passivation film and Fe matrix combined closely, and no defects appeared such as crack. Dark green passive film mainly contained chromium, oxygen, phosphorus, zinc, and composed by $CrPO_4$, $Cr(OH)_3$, $CrOOH$, Cr_2O_3 , $Zn(OH)_2$, $2ZnO \cdot CrO_3 \cdot H_2O$, $Zn_3(PO_4)_2 \cdot 4H_2O$, and Ag.

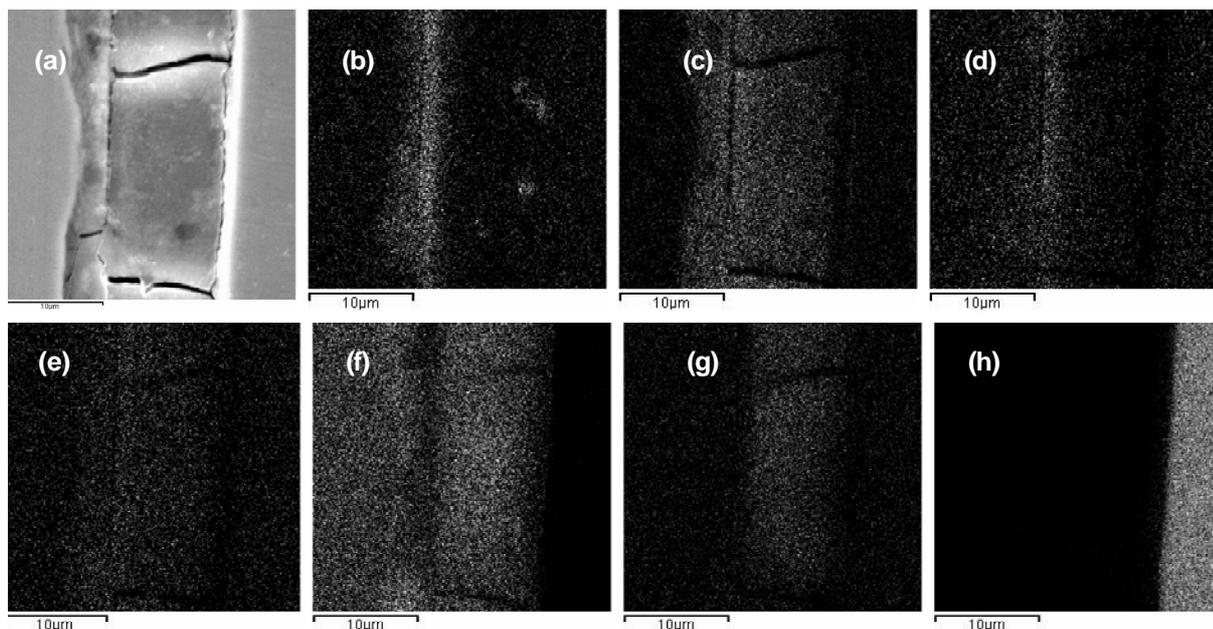
Fig. 4. Fracture surface EDS surface scan analysis of specimen with blackishgreen colored passivation film: (a) Fracture surface SEM morphology of specimen; (b) Chromium; (c) Oxygen; (d) Phosphorus; (e) Sulfur; (f) Zinc; (g) Chlorine; (h) Iron.

Fig. 4 showed that the distribution intensity of Chromium, oxygen, phosphorus was significantly

higher and S was slightly higher in passivation film than in zinc coating, however the distribution intensity of Zinc, Chlorine was higher in zinc coating than in passivation film. Chlorine occurred in the

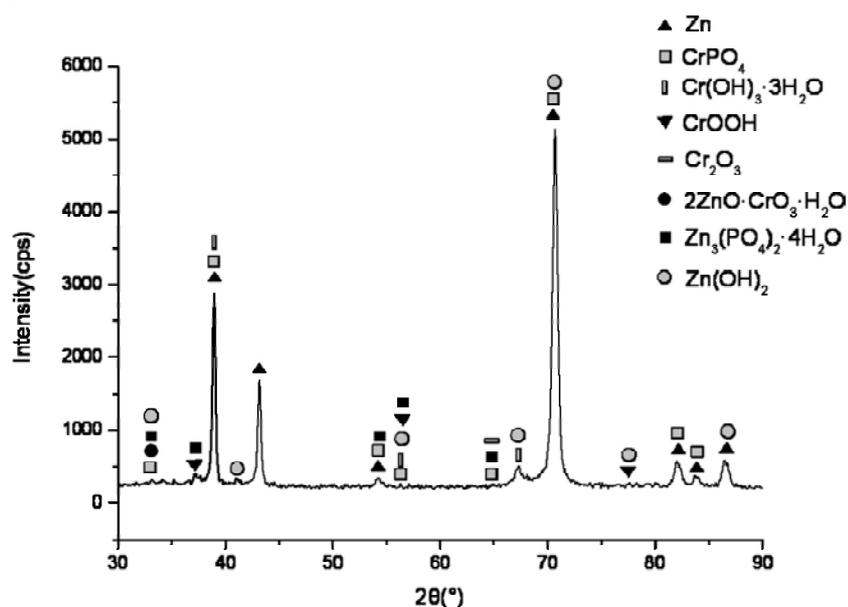
Fig. 5. XRD patterns of the specimens with and without blackishgreen colored passivation film: (a) Specimen with blackishgreen colored passivation film; (b) Specimen without passivation film.

Fig. 5a presents X-ray diffraction patterns of dark green passivation samples. As shown, there were Zn diffraction peaks in the diffraction pattern. We believed that these peaks were produced by electro-galvanized layer coated on the iron matrix. To this purpose, detection of X-ray diffraction was done on the galvanized samples without passivation. Test

results are shown in Fig. 5b. The six diffraction peaks were all Zn peak in Spectrum 5b, and all the diffraction peaks were relatively sharp, indicating high crystallinity of Zn [3].
